# Confirmation Certificate

# MOT test certificate

# Pre Scan Vehicle System Report

# Maintenance list

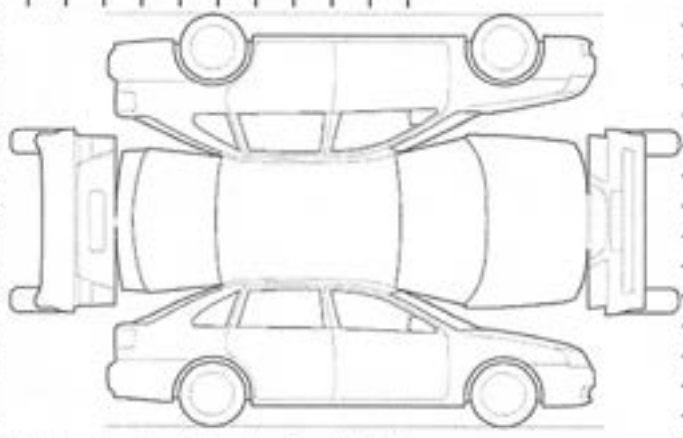
<p><b>BODYWORK / WINDOW GLASS / MIRRORS</b></p> <p>D = DENT                  S = SCRATCH                  CH = CHIP                  CR = CRACK                  W = WHEEL DAMAGE                  T = TREE SAP MARKS                  B = BIRD DROPPINGS MARK</p>

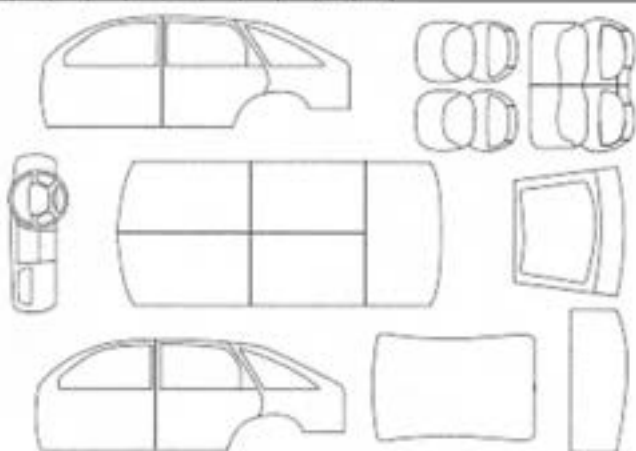
<p><b>INTERIOR SEATS / CARPET / DASHBOARD / ROOF</b></p> <p>T = TEAR                  S = SCUFF / WEAR                  B = BROKEN                  BN = BURN                  M = MISSING</p>

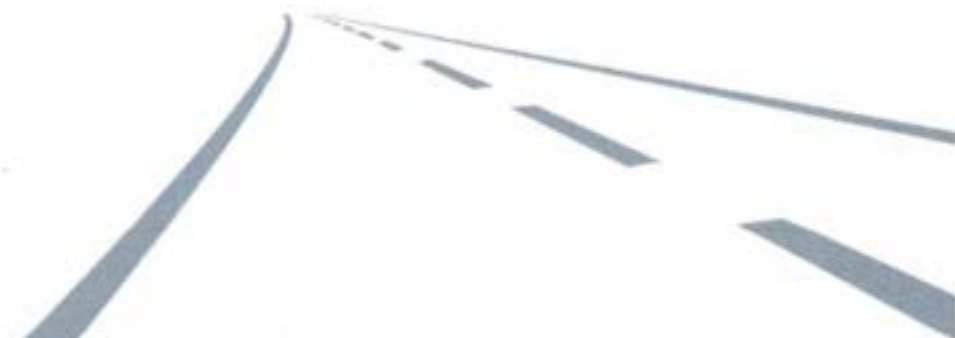
### Systems Analyzed: 24

- ✔ 01-Engine Management: 0
- ✔ 02-Transmission: 0
- ✔ 03-Brake Electronics: 0
- ✔ 08-Airco: 0
- ✔ 09-Central Electronics: 0
- ✔ 13-Adaptive Cruise Control: 0
- ✔ 15-Airbag - SRS: 0
- ✔ 17-Instrument Cluster: 0
- ✔ 19-Diagnostic Data Interface-Gateway: 0
- ✔ 22-4WD Electronics: 0
- ✔ 36-Seat Memory Driver: 0
- ✔ 3C-Lane Change Assistant: 0
- ✔ 42-Door Electronics Driver: 0
- ✔ 44-Steering Assist (separated): 0
- ✔ 52-Door Electronics Passenger: 0
- ✔ 5F-Information Control Unit: 0
- ✔ 6C-Back Up Camera: 0
- ✔ 6D-Trunk Electronics: 0
- ✔ 76-Parking Help: 0
- ✔ 2B-Electronic Steering Column Lock: 0
- ✔ 75-Telematics Communication Unit: 0
- ✔ A5-Front Sensor Driver Assistance System: 0
- ✔ B7-Access/Start System Interface: 0
- ✔ CA-Control Module For Sunroof: 0
- ✔ OBDII Codes (\$03): 0
- ✔ OBDII Permanent Codes (\$0A): 0

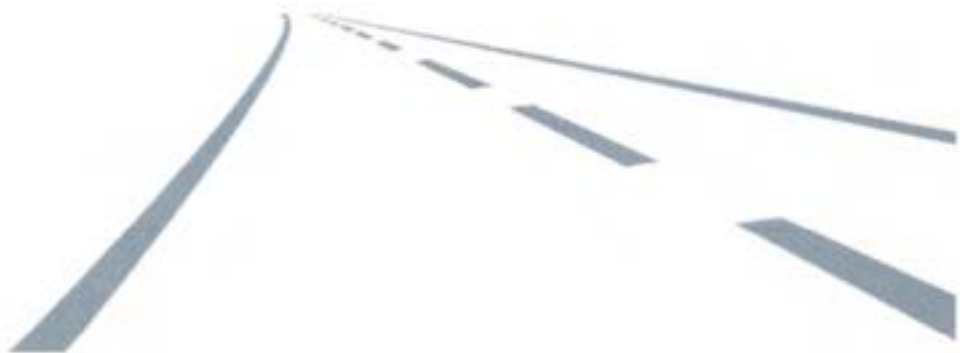
**READINESS MONITORS**

**Tests Complete**

- Fuel System
- Comprehensive Component

**Not Complete**

- EGR/VVT
- NMHC Catalyst
- NOx Aftertreatment
- Boost Pressure System
- Exhaust Gas Sensor
- PM Filter
